TECHNICAL SERVICE BULLETIN

Ref.: AUDIO
No.: AU002-96
Date: OCTOBER 25, 1996
Model: ALL MODELS

Title: AM STATIC NOISE ON VEHICLES WITH POWER ANTENNAS

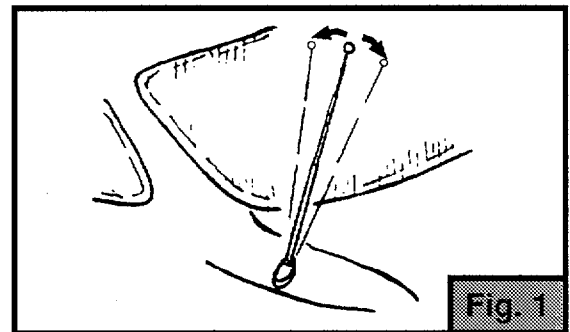
Fig. 1

1. Tune the radio to a strong, static-free AM station and slowly move the tip of the antenna mast forward and back approximately 2 inches (Fig. 1). If static noise is not heard, go to Step 2. If static noise is heard during antenna movement, replace the antenna mast and go to Step 3.

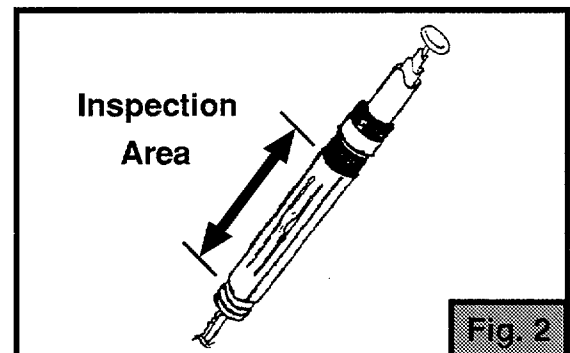
Fig. 2

2. Remove the antenna mast and inspect the base of the mast for corrosion and damage (Fig. 2). Clean with 1500 grit sandpaper.
3. Remove the antenna assembly and inspect the inner fender around the antenna hole for corrosion (Fig. 3). Clean with 1500 grit sandpaper.

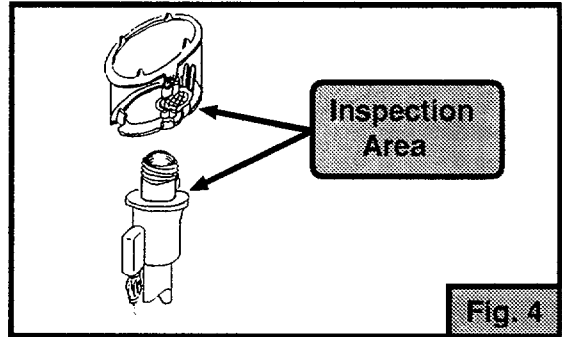
Fig. 4

4. Remove the antenna spacer grommet at the top of the antenna assembly and inspect for corrosion (Fig. 4). Clean with 1500 grit sandpaper.

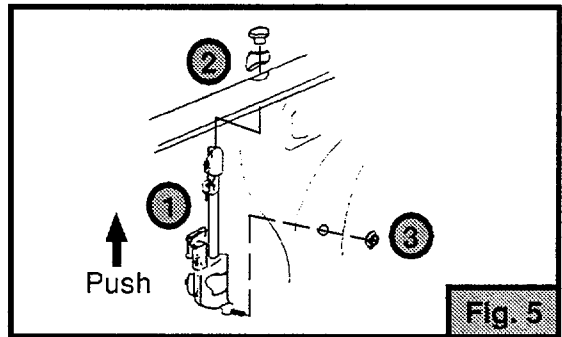
Fig. 5

5. Reinstall the antenna assembly. Be sure to install the external antenna nut (escutcheon) first. Then install the nut which holds the assembly to the inner bracket (Fig. 5).

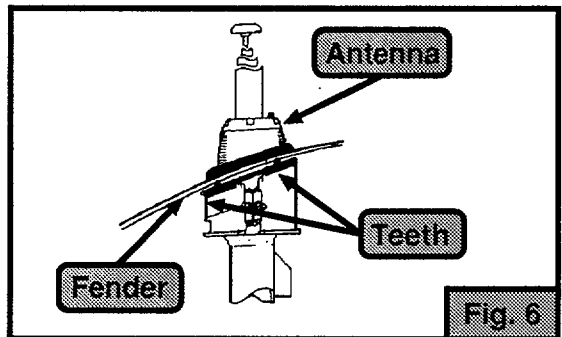
Fig. 6

6. Check to make sure that the teeth on the antenna spacer grommet make good contact with the inner fender well (Fig. 6).

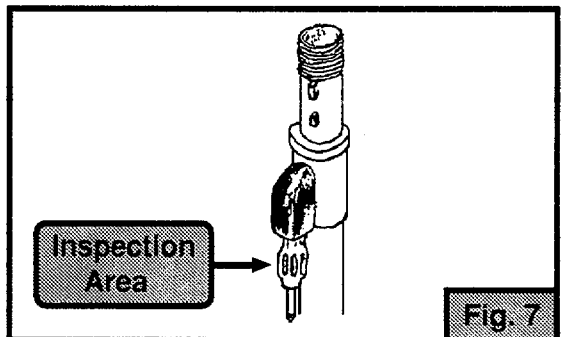
Fig. 7

7. Inspect the antenna cable connection and clean as necessary (Fig. 7). Reconnect the antenna cable, the wire harness and the drain hose.
