Vauxhall Cavalier/Opel

4x4 Accumulator - Assembly Removal, Bulb Change & Reinstallation

This procedure is based on the specimen vehicle, a March '93 2.0l 16v Cav. Turbo, and some detail may differ to variants fitted with 4WD. It has been designed to deal specifically with changing a faulty 'Accumulator bulb' and involves removing the accumulator assembly from the vehicle, stripping it as far as reasonable, to facilitate changing the accumulator bulb, rebuilding, reinstalling into the vehicle. And finally, bleeding the steering hydraulic system.

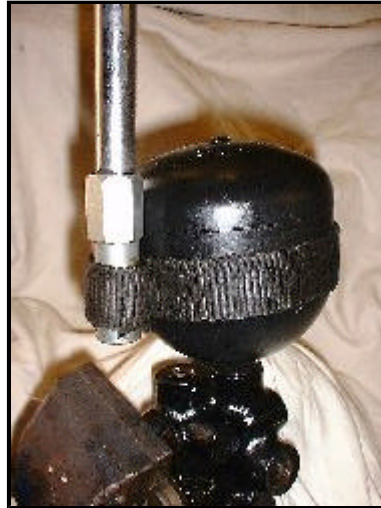
Figure 4b

The Accumulator block in the vice with the webbing oil filter removal tool attached.

836. Using the special tool, or the webbing oil filter tool, (former recommended) very carefully tighten the bulb to 43-50 Nm (38 ft lbs), as shown in Fig.4b.

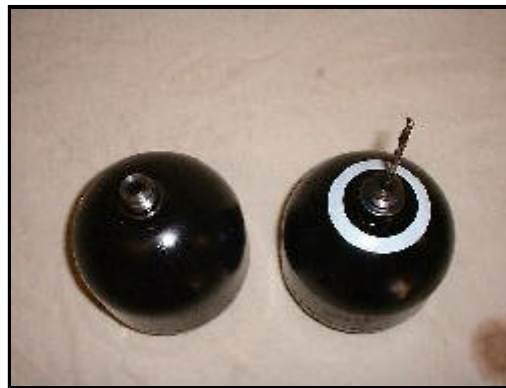
Figure 5

The two Accumulator bulbs. The recall item is without white markings and the new one has a white ring. Note the twist drill in the neck of the new bulb - see para. 826

826. Select a twist drill that is a reasonable fit in the neck of the (old) bulb and insert the blunt end into the bulb. (As if placing the bit in a drill chuck). i.e. Cutting end outside. (Fig.5)

827. Apply some body pressure to the drill bit. The membrane inside 'sprung' quite easily with a small pressure applied. Whereas, the new bulb would not move at all under the same pressure. At £116 the author chose not to apply too much pressure to the new bulb but it certainly would not move under hand pressure, which the old one did.

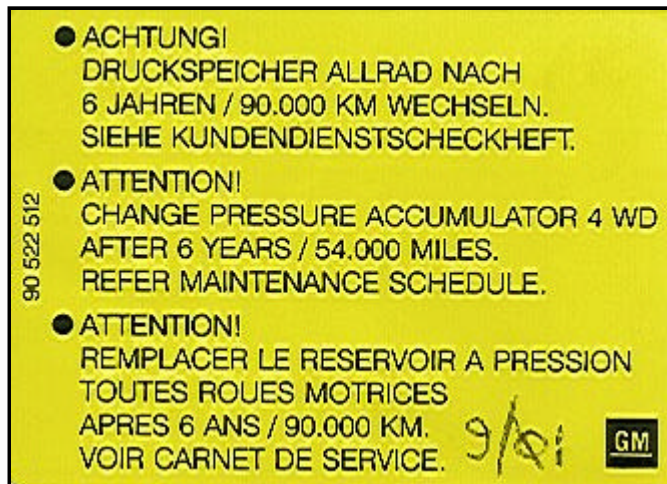
Figure 7

Shows the label supplied with the new Accumulator Bulb

859. If the accumulator has been replaced, locate the yellow sticky warning label that was supplied with the new bulb. Write on the label, the date the unit was changed and the current mileage. Place the label in a prominent position adjacent to the accumulator. (Fig.7) e.g. The relay box cover.

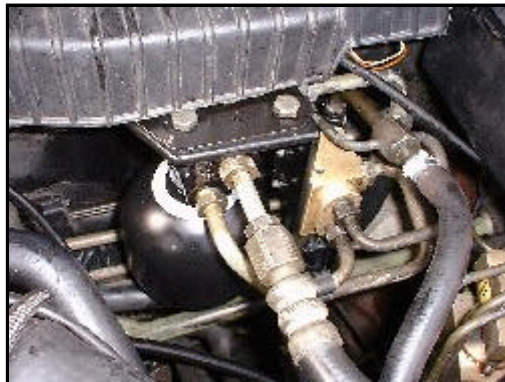
Figure 8

The re-installed Accumulator assembly. Note the white ring now clearly visible.
