TOYOTA TECHNICAL SERVICE BULLETIN

REF.: BRAKES
NO.: BR94-002
DATE: FEBRUARY 7, 1994
MODEL: ALL MODELS

BRAKE VIBRATION AND / OR PULSATION

This TSB outlines the causes of brake vibration and pulsation, as well as the best corrective measures to use.

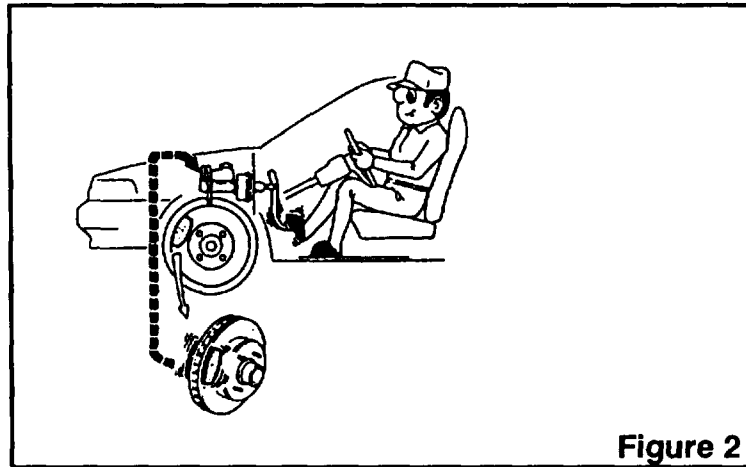
Figure 2

Applying brakes causes the brake pedal to pulsate. This brake pulsation sometimes causes the steering wheel to oscillate when the brakes are applied (see **Figure 2** below).

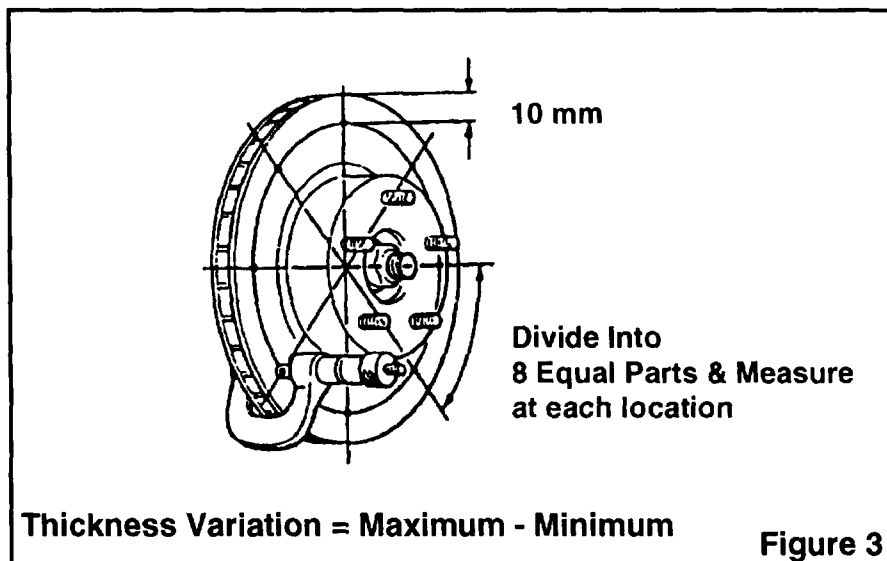
Figure 3

Brake rotor thickness variation causes brake vibration due to changes in the braking force as thick/thin portions of the rotor pass the pads. Brake rotor thickness variation can be measured with a micrometer as shown in **Figure 3** below.

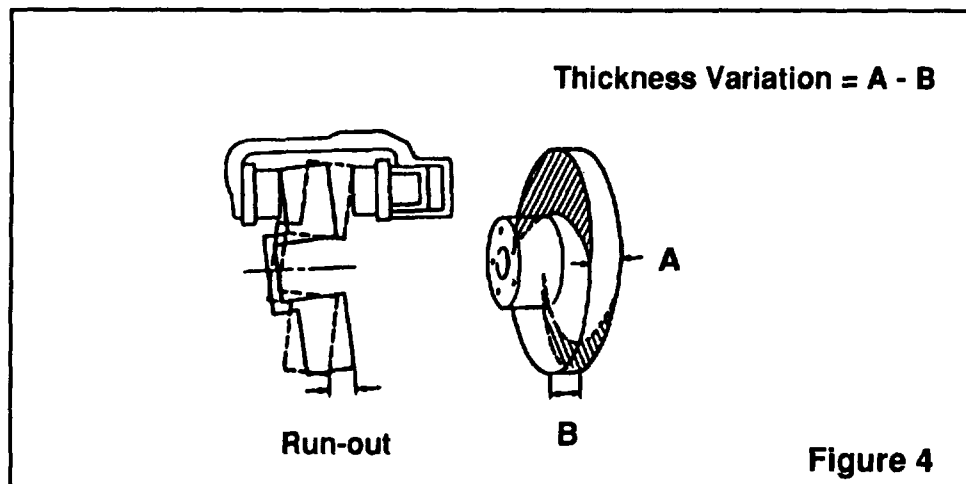
- **Rotor run-out** can be caused by poor mating of flanges between the hub and rotor when assembled as a unit. Manufacturing tolerance stack-up of the rotor and hub may also cause excessive rotor assembly run-out (**see Figure 4 below**).
- If there is rotor run-out, a portion of the rotor comes into contact with the brake pad on each rotor revolution. If left like this, the portion of the rotor that contacts the brake pad becomes worn, creating **thickness variation**.

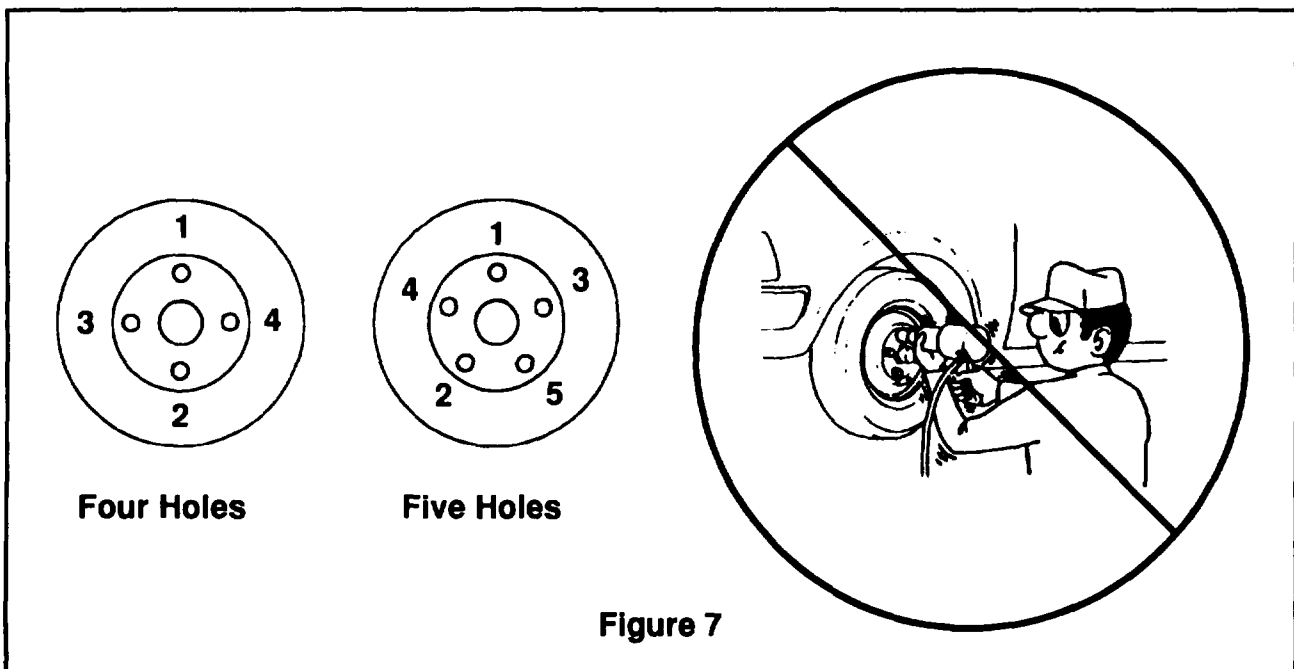
- Tighten lug nuts to the specified torque following a star sequence when installing wheel (see Figure 7 below).

Note: DO NOT USE AIR IMPACT WRENCH.
